# Centennial Park Accessibility Report/ Onsite Review 6-8-19

Chassell Township requested a formal site review of their premier Centennial Park along the shoreline of Lake Superior. SAIL had earlier in the year supported the Township's efforts to have their updated five year Parks and Recreation Plan accepted by the Michigan Department of Natural Resources (DNR). At that time, SAIL recommended the Township consider a formal site review of Centennial Park for ADA compliance. Lynn Gierke, the Township Clerk managed arrangements for a formal site review in June after the Township voted to pay for a site review conducted by the Superior Alliance for Independent Living, a member of the Disability Network of Michigan(SAIL) to evaluate the site, and report the findings.

On June 8, 2019, SAIL evaluated Centennial Park. The evaluation was performed by Lucy Wilcox, a certified ADA Coordinator, and Allen and Joan Beauchamp, members of the Ambassador Accessibility Team. The team was joined by the Township Clerk, Lynn Gierke and a member of the Planning Committee of Chassell Township, Brian Waters.

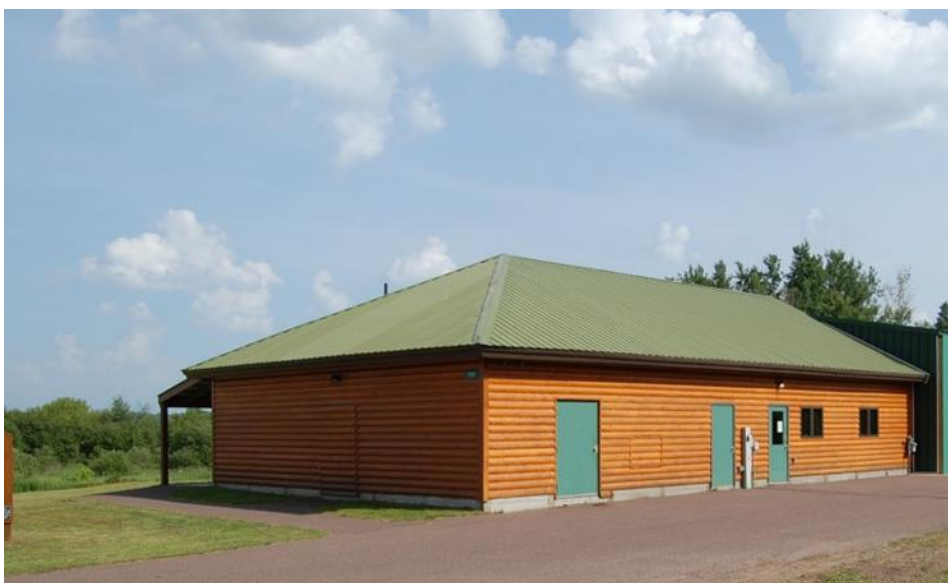
## II. Approach and Entrance/Egress at the Pavilion- Parking available in far side of the Pavilion

**A. The Parking Lot:** The parking lot surface is in good condition and there is more than adequate handicapped parking provided. Currently there is no standing signage to mark the Handicap accessible spaces as required by the ADA. The parking spaces are marked by paint markings on the pavement and there is no Van accessible parking designated. **Level 1 Recommendations: 1.** Purchase signage that can be posted at a minimum of 60 inches above the ground and designate 2 Van accessible parking spaces at the edge of the

parking lot close to Lake Superior. Given the space available designating the two spaces 8 feet each and sharing an access aisle of 8 feet would utilize spaces already in place. **Level 1 Recommendations:** 1. Purchase signage that can be posted at a minimum of 60 inches above the ground and designate 2 Van accessible parking spaces at the edge of the parking lot close to Lake Superior. Given the spaces are already designated handicapped parking--the main change is the designation as Van Accessible and these spaces do provide the easiest access route into the Pavilion.

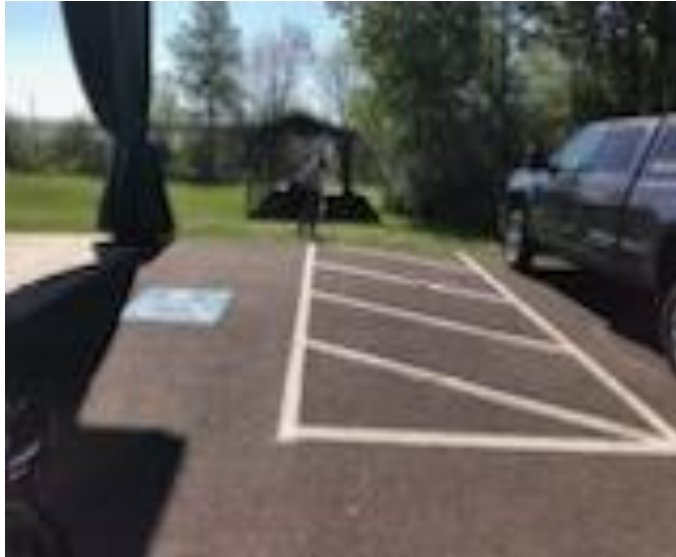
2. The five accessible parking spaces of 8 ft wide positioned next to the Pavilion as you reach the west side of the parking lot actually exceed the required number by ADA guidelines and Chassell is commended for their planning. **Level 1 modification-** There is the need to meet ADA signage standards for the five spaces with each space marked with handicap signage at least 60 inches above the parking lot. Painted signage is optional and during winters in the UP not effective. We recommend the new signage that shows the wheelchair in motion, the Go Logo. It is essential to preserve the access lanes of at least 5 feet wide shared by 2 autos.

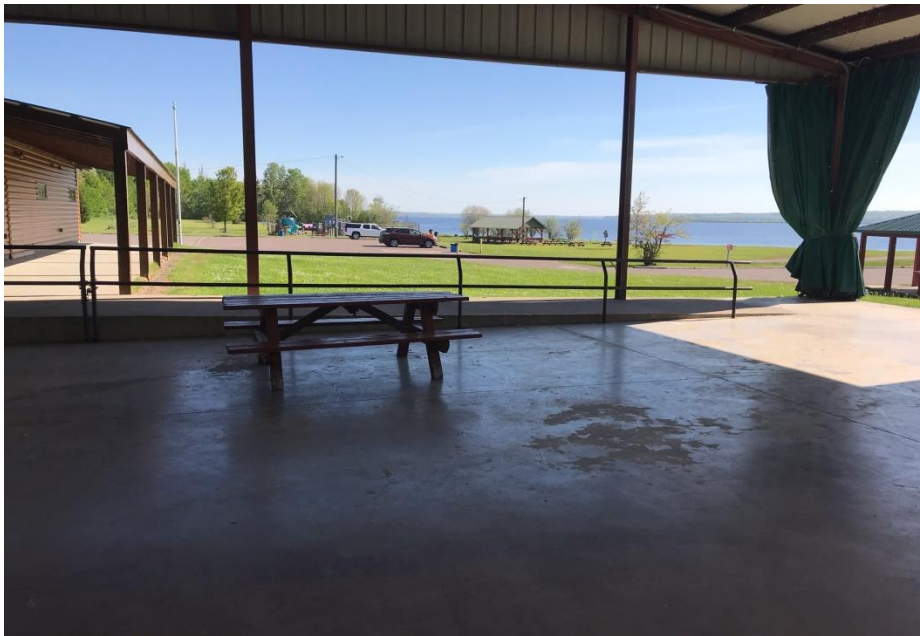
### B. Accessible Entrance to the Pavilion—

From the parking lot, there is an accessible ramp up to the main entrance to the Pavilion. Slope does not exceed allowable 1:20, i.e. for every inch of height change there is at least 20 inches of route run.

The entrance door on the west side of the building is accessible. The threshold into the building is  $\frac{3}{4}$  inch which is the outside limit of height allowed. The interior threshold is  $\frac{1}{2}$  inch beveled with rubber adhesive. The door can be opened with less than 5lbs of pressure and the door handle is 35 inches above ground—within the limit of a maximum height of 48 inches above ground. The door

opening exceeds the minimum of at least 32 inches between the face of the door and the stop when the door is opened 90 degrees.

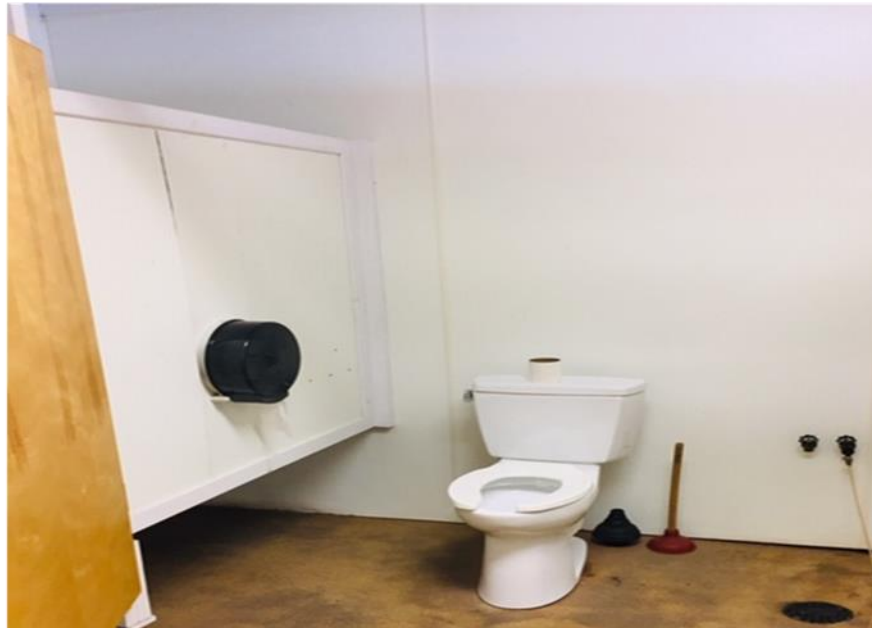
**III. Pavilion Restrooms**---Both the men and women's restrooms are identical and neither is accessible. There are serious issues with the doors, the placement of the toilets, the lack of hand bars and the inability to modify the existing restrooms to become accessible without significant remodeling. The particle board used to separate the stalls make it impossible modify with mandatory hand bars. The conversation among the SAIL team and Chassell representatives was that for the Pavilion to have accessible restrooms is a long term project and we moved to a focus on the restrooms that were built recently with the intention to be accessible. It was noted by the Township Clerk that for their large events like the upcoming Strawberry Festival, they rent a handicap accessible porta-john for the event and placed at the edge of the Pavilion parking lot. This modification is a good step toward creating an accessible event at the Pavilion and the Township is commended for that.

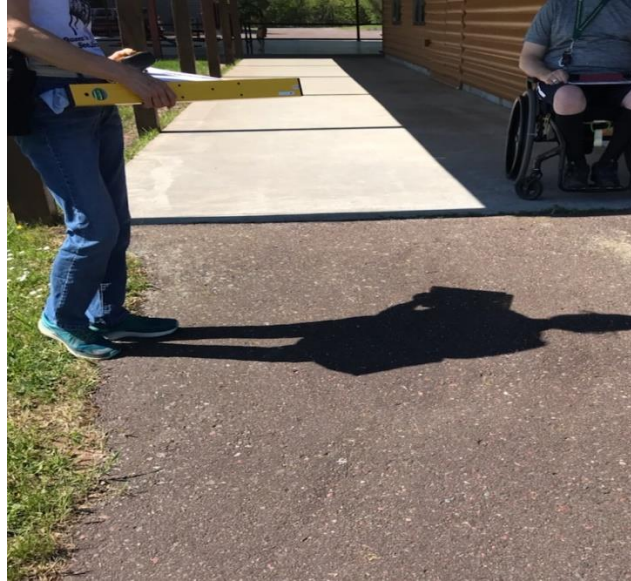
**IV. Accessible Egress from the Pavilion:** We moved to exiting the Pavilion building and found that the route to leave the building on the pathway to the playground and fishing pier was raised above the  $\frac{3}{4}$  inch allowed. To become compliant will be a **Level I modification**.

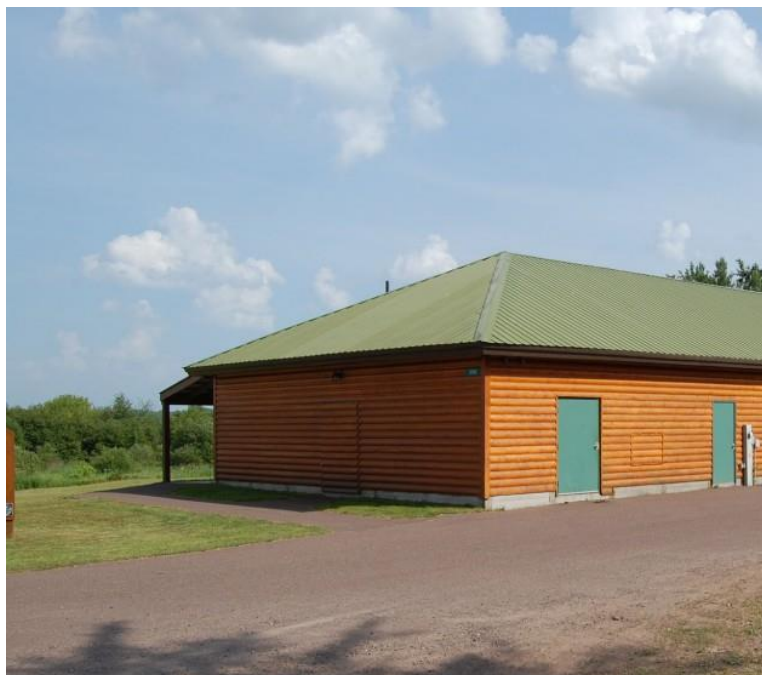
It is not an option to leave by the door on this side of the Pavilion near the Playground parking lot due to the step down from the door. This could be remediated with a simple ramp to achieve the threshold of a maximum of  $\frac{3}{4}$  an inch and a slope of no more than 1:20 inches. This is also a **Level 1 modification**.

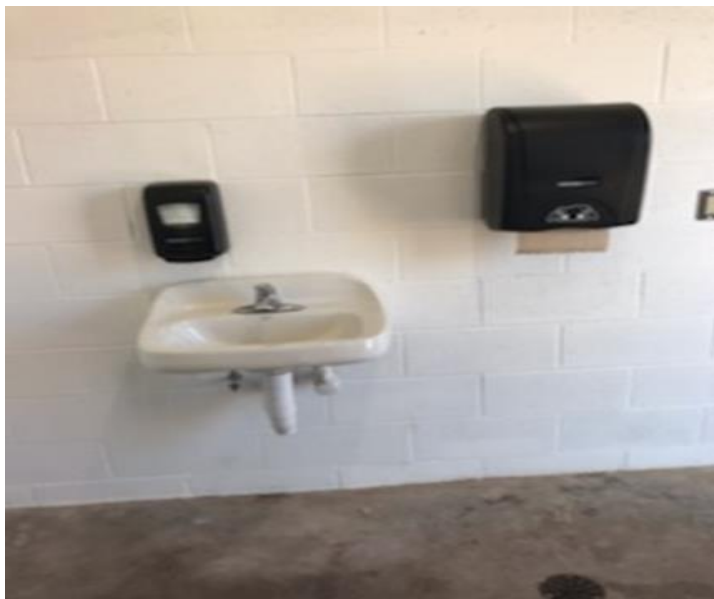
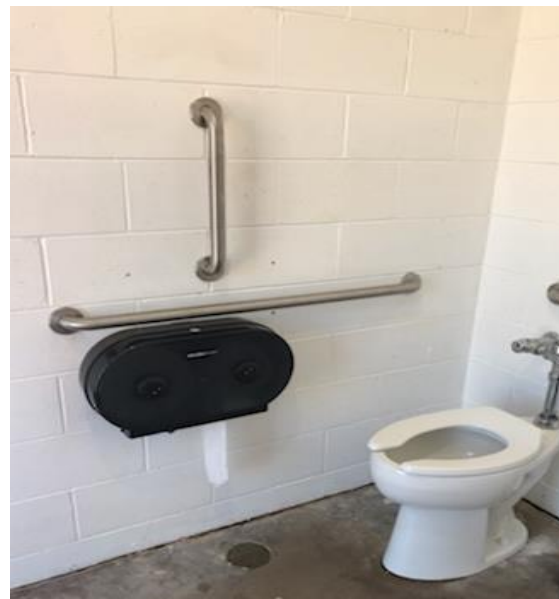
**V. Toilet rooms near the fish cleaning station-** The review team directed their consideration of accessible toilets to the separate toilet rooms near the fish cleaning station. The Chassell participants believed the two restrooms there are accessible. We will review accessible routes to the building in the next section. The two restrooms are identical and both are accessible with one readily resolved barrier. To be accessible there must be a turning radius once inside the toilet room of 60 inches. That standard is met. There must be hand bars placed with specific requirements of the length of the hand bars and the alignment with the toilet. The diagrams above show the required measurements for the hand bars in an accessible bathroom. The standards were met for the hand bars behind the toilet and on the wall beside the toilet.

However, adding the vertical bar (which is definitely not an ADA standard) created an error in the location of the toilet paper holder so it is inaccessible to the user and the space between the bar and toilet holder is not sufficient. There were holes in the cement block that indicated the holder had been moved when the vertical bar was added. **The Level 1 recommendation** is to revert to the original set up without the vertical bar.

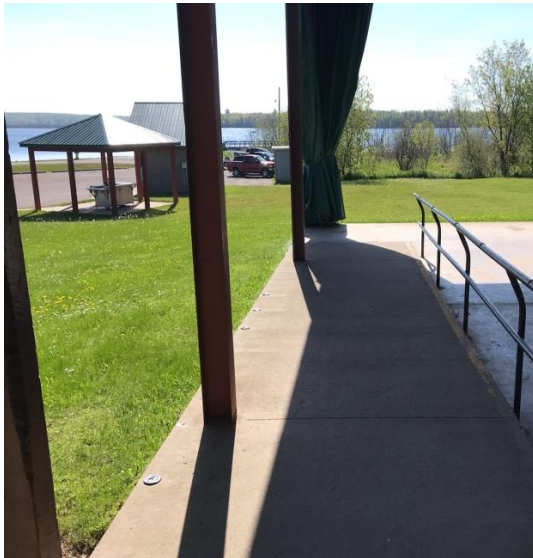
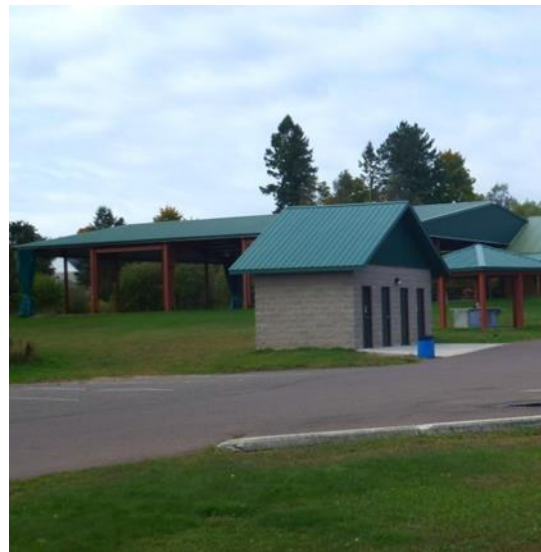
### VI. Approach to Restrooms near the Fish Cleaning Station

A. Route to the new restrooms—at this time there is not an accessible route with the required slope. The surface of an accessible route needs to be firm and stable and slip resistant. The route must meet the requirements for maximum slope of 1:20 inches and the cross slope requirement of 1:48 per inch. The access to the restrooms from the Pavilion could be a pathway down the grassy slope to the restroom building (see Attachment 1\_Drawing of Centennial Park). The drawing provides detail on the entire park and is helpful in considering other options for an accessible route. One possibility is to come out of the Pavilion by the parking lot for the playground and down to the boat launch and pier on a partially existing pathway. It could be that a combination for the two would be needed in terms of an accessible route to the restrooms from the playground area. It is in the ADA Guidelines to

attempt the easiest (i.e. shortest) accessible route for the individual with disability.

**This is a Level 3 recommendation** in that it will require exploring different options and will require some new construction.

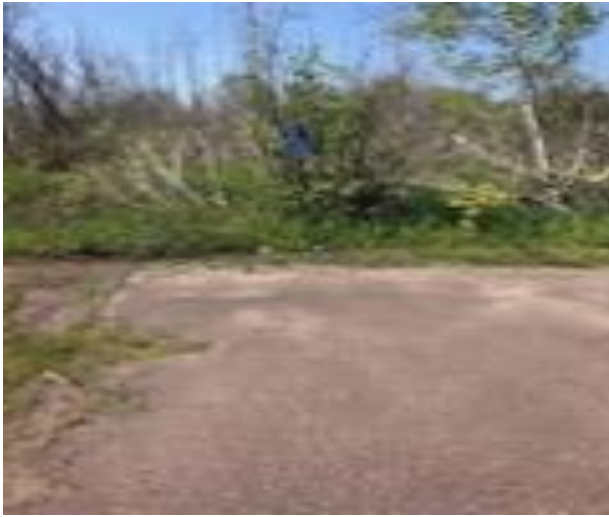
## B. Accessible Parking at the Parking near the Pier

Almost hidden from sight is the handicap signage that is above ground but barely visible due to the overgrowth of plants and bushes. **Level 1 Recommendation** to use new signage and consider Van accessible space 8ft wide with access lane of 8 ft to assure larger vehicle could be accommodated at this site by the waterfront.

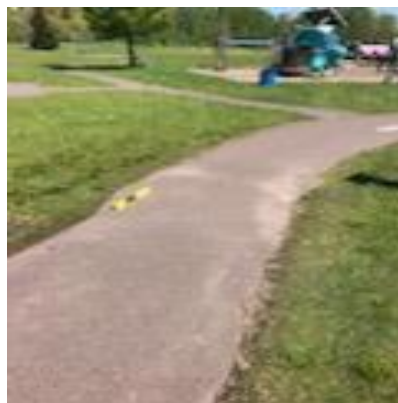
Pathway down to Playground

- A. The picnic pavilion is accessible with the need to mend the juncture from the pathway into the pavilion so it is no higher than  $\frac{3}{4}$ ". (Level 1 modification)
- B. The pathway from the parking lot down to the playground area has a slope that exceeds the maximum of 1:20. If this is to be considered an accessible pathway, there will need to be reworking of the pathway down from the parking lot. As mentioned above, this could be done as part of an accessibility route to the accessible toilets.
