2013 Qualitative Assessment of Eurasian watermilfoil *Myriophyllum spicatum*  
(including *Myriophyllum sibiricum x spicatum*) of Pike Bay – Chassell Township,  
Houghton County, MI.

Prepared for the Citizen's Committee for Pike Bay Restoration

Many Waters, LLC

October 1<sup>st</sup> 2013

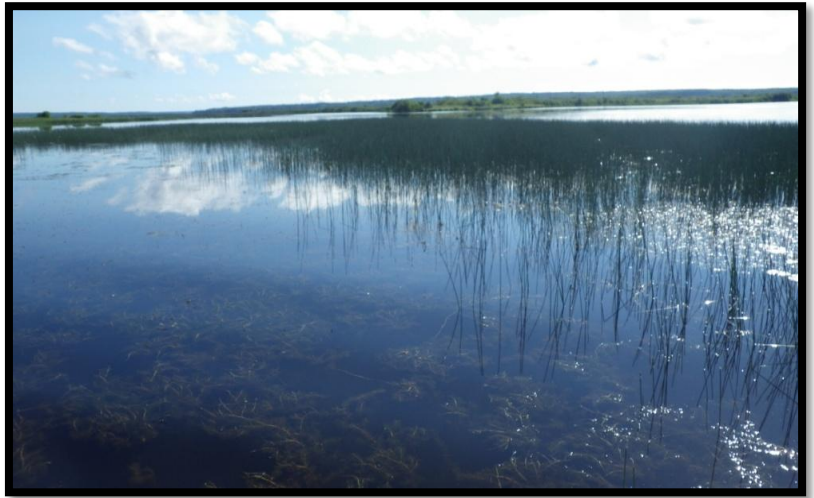
Using the July 20<sup>th</sup> and 21<sup>st</sup> 2013 assessment findings, the extent and density of Eurasian watermilfoil (EWM) and laboratory confirmed hybrid watermilfoil (HWM) in Pike Bay is wide spread. Overall densities are consistent with nuisance level conditions typified as dense surface matted monotypic beds. The distribution encompasses the majority of the littoral zone and extends from the shore or the near shore area where sand is the dominant substrate to depth of maximum rooted vegetation. Where sandy substrates near shore are not present, EWM/HWM grows very closely to shore or adjacent to near shore emergent vegetation.

EWM/HWM growing along the edge of hard stem bulrush

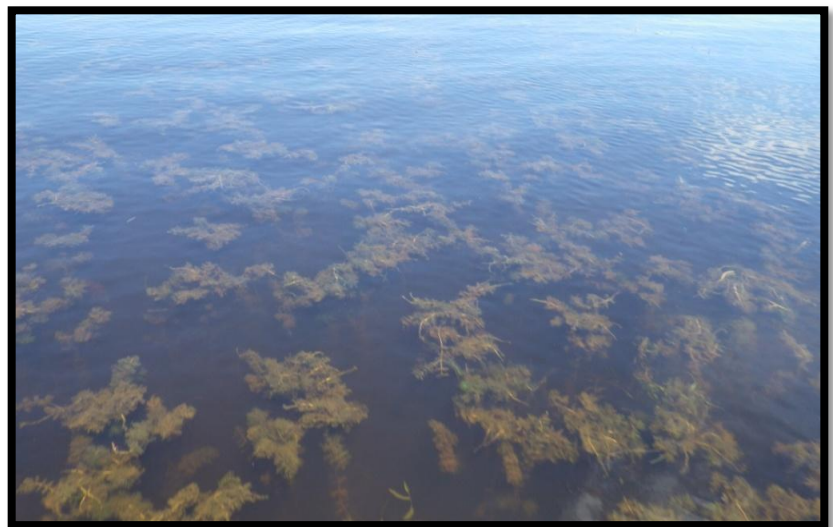
Determining the extent of EWM/HWM as a percentage of littoral frequency is outside the scope of this qualitative assessment. Nevertheless, based on visual observations made, the extent of EWM/HWM encompasses approximately 80%-90% of the littoral zone of Pike Bay. Very little to no EWM/HWM was found at the historical log landing/mill site located south of the park along the western shore. A conversation with the landowner described the adjacent waters to the old mill as having submersed wooden planks along the lakebed, leaving little area for any aquatic vegetation to become rooted and established.

High density bed of EWM/HWM in Pike Bay

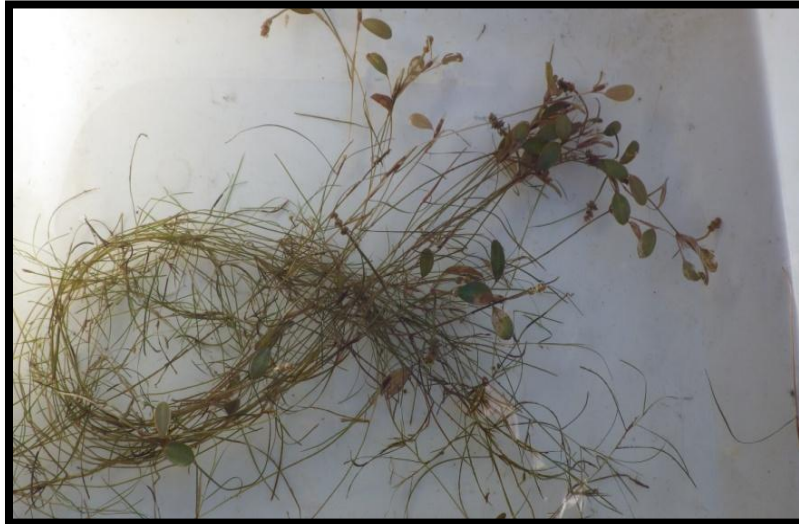
*Potamogeton vaseyi*

A State of Michigan threatened aquatic plant species *Potamogeton vaseyi* is known to occur. Several photos and a sample was collected. Dr. Tony Reznicek at the University of Michigan verified the photos as *Potamogeton vaseyi*. The sample is pressed and dried and will be delivered to Dr. Reznicek at the University of Michigan this fall. Primarily this plant is located within the near shore region of D-13, but also along the northeastern side of Pike Bay.

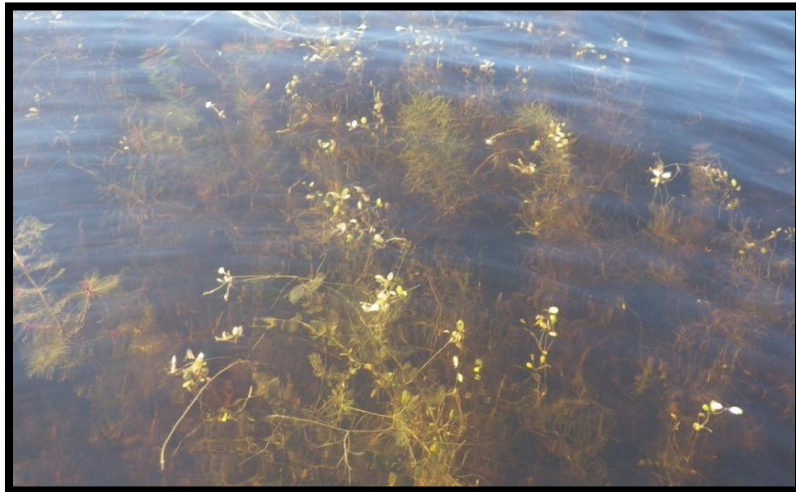
*Potamogeton vaseyi* growing in Pike Bay

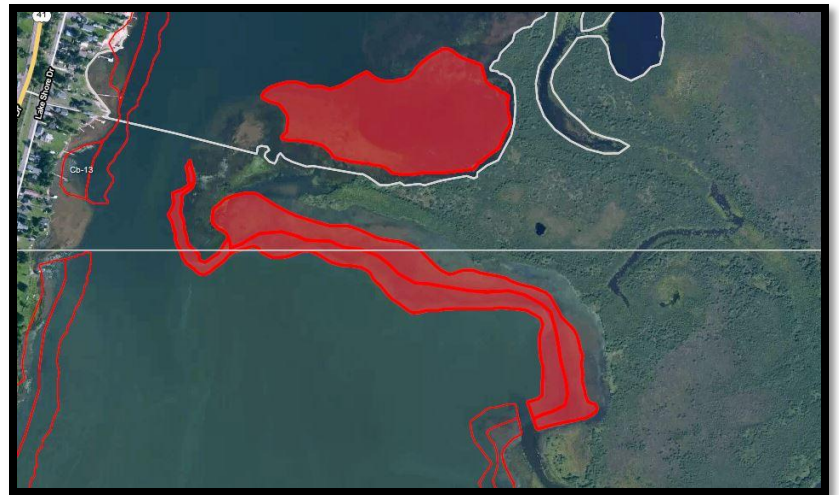
The northeastern side of Pike Bay is an expansive wetland complex owned by the MDNR. This large undeveloped natural area provides vital ecological habitat for local and migrating birds and fish. It is also, where the majority of the *Potamogeton vaseyi* plants are located. The Sturgeon River enters Portage Lake just to the northeast of Pike Bay, however, the Sturgeon River Log Weir enters into Pike Bay along the northeastern side. During the survey, it is obvious where the river got its name due to the large sturgeon observed displaying their acrobatics out of the water.

Areas affected with EWM/HWM adjacent to State of Michigan Lands.

To reduce the level of EWM/HWM in Pike Bay, the most cost effective approach will be to conduct annual herbicide treatments. Understand that once management of an invasive species begins, it is a continual process, not once and done. Eradication is not feasible; once an invasive aquatic plant species becomes established in a system it will more than likely never be eradicated. The aim of any herbicide management will be to reduce size but also density of the target species and this may take multiple years to accomplish both. Anticipate annual reduction in density and size, however, significant reduction in overall treatment acreages may take several years to accomplish.

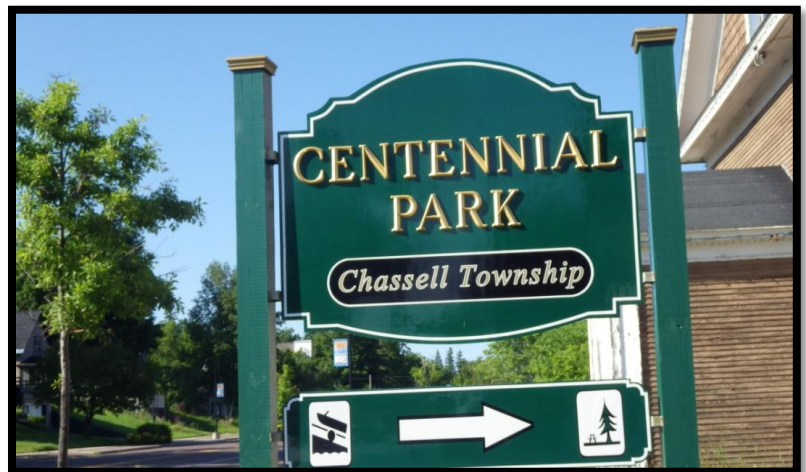
Centennial Park at Pike Bay serves as an access point to the greater Portage Lake system. The park offers a beach, picnic area, boat launch and fishing pier that is used by visitors and local residents. Currently, the majority of the swimming area is occupied by EWM/HWM in high densities and is a recreational impediment to beach users. The level of EWM/HWM present in Pike Bay poses a significant risk to the continued recreation use of the bay, access to the lake by riparian property owners and park users.
