Pike Bay Aquatic Vegetation Evaluation with Professional Management Recommendations Houghton County, Michigan

Provided for: The Chassell Township Board

**Prepared by: Restorative Lake Sciences
Jennifer L. Jermalowicz-Jones, PhD, CLP
Water Resources Director
18406 West Spring Lake Road
Spring Lake, Michigan 49456
www.restorativelakesciences.com**

©The information, format, and ideas in this report are proprietary property of Restorative Lake Sciences (RLS) and cannot be used without permission by RLS. September, 2023.

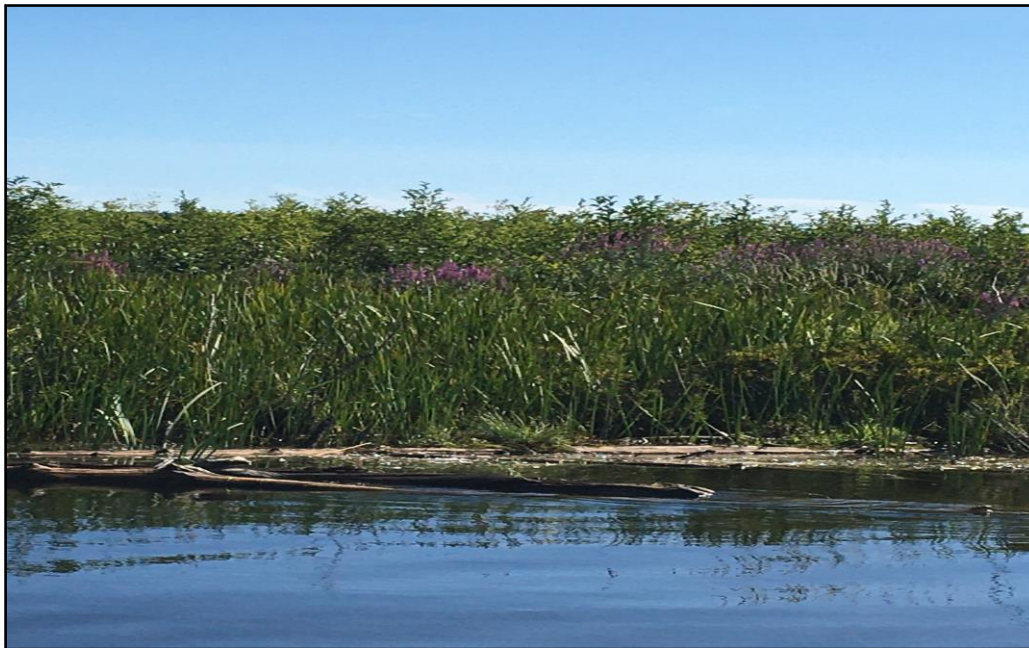
Figure 9. Invasive Purple Loosestrife around the shoreline of Pike Bay (August 27, 2023).

3. Purple Loosestrife can be hand-removed without the use of herbicides were it is found. The roots must be removed with a shovel and all of the plant discarded in a sealed bag.

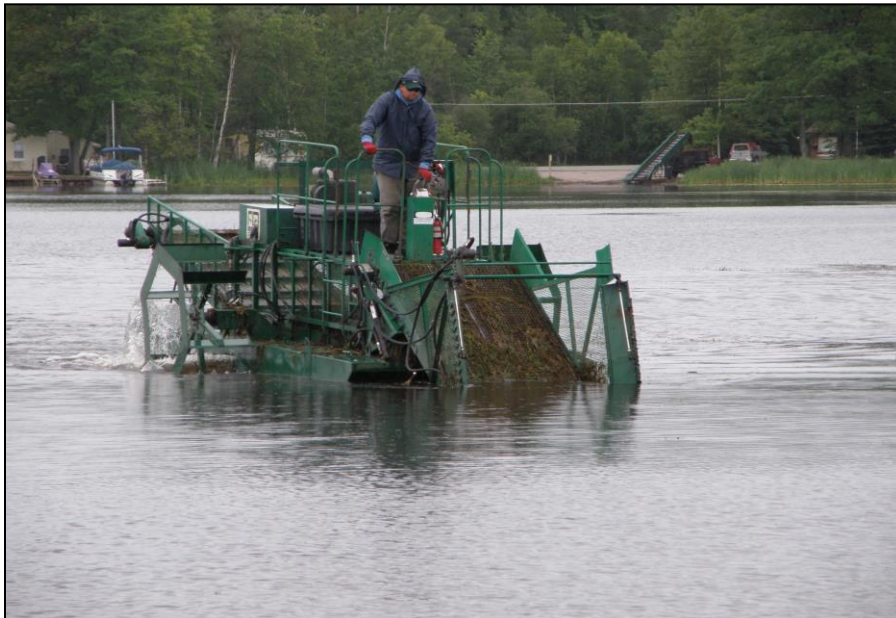
Mechanical harvesting involves the physical removal of nuisance aquatic vegetation with the use of a mechanical harvesting machine (Figure 45). The mechanical harvester collects numerous loads of aquatic plants as they are cut near the lake bottom. The plants are off-loaded onto a conveyor and then into a dump truck.

Harvested plants are then taken to an offsite landfill or farm where they can be used as fertilizer. Mechanical harvesting is preferred over chemical herbicides when primarily native aquatic plants exist, or when excessive amounts of plant biomass need to be removed. **Mechanical harvesting is usually not recommended for the removal of watermilfoil since the plant may fragment when cut and re-grow on the lake bottom.** In addition, it does not allow for removal of vegetation in target areas since Pike Bay has invasive milfoil growing with numerous native aquatic plant species.

Figure 45. A mechanical harvester.

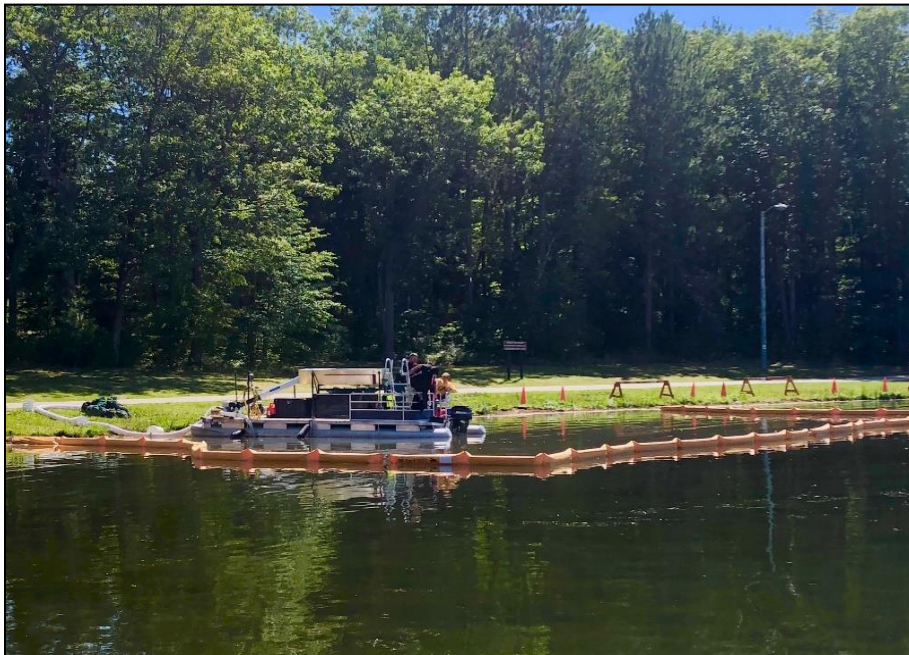
Suction harvesting via a Diver-Assisted Suction Harvesting (DASH) boat (Figure 46) involves hand removal of individual plants by a SCUBA diver in selected areas of lake bottom with the use of a hand-operated suction hose. Samples are dewatered on land or removed via fabric bags to an offsite location. **This method is generally recommended for small (less than 10 acres) spot removal of vegetation since it is usually cost-prohibitive on a larger scale.** The advantage it has is that it can be selective in what species it removes since a diver is guiding the suction hose to targeted plants.

This process may remove either plant material or sediments and may require a USACE bottomlands permit. Furthermore, this activity may cause re-suspension of sediments (Nayar et *al.*, 2007) which may lead to increased turbidity and reduced clarity of the water.

Figure 46. A DASH boat for hand-removal of watermilfoil or other nuisance vegetation. ©Restorative Lake Sciences

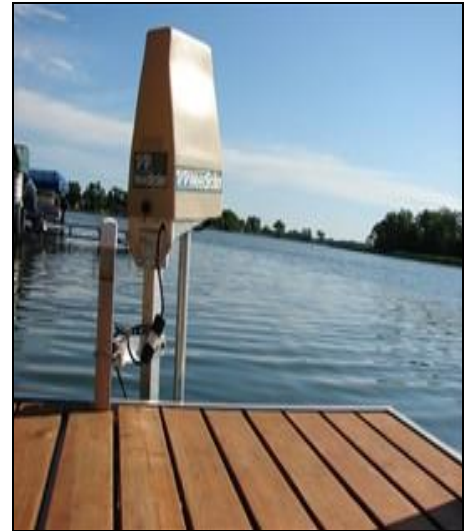
Weed Rollers are electrical devices which utilize a rolling arm that rolls along the lake bottom in small areas (usually not more than 50 feet) and pulverizes the lake bottom to reduce germination of any aquatic vegetation in that area. They can be purchased online at: www.crary.com/marine or at: www.lakegroomer.net.

Figure 48. A Weed Roller.

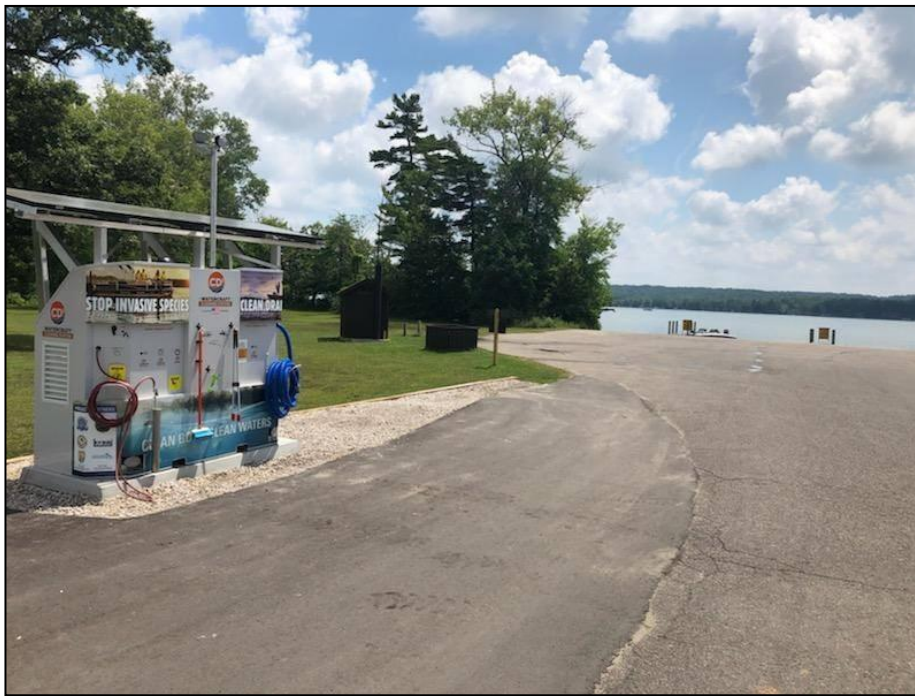
Critical elements of this education include: 1) how to approach boaters, 2) demonstration of effective boat and trailer inspections and cleaning techniques, 3) the recording of important information, 4) identification of high-priority invasive species, and 5) sharing findings with others. **If a boat washing station is installed on Pike Bay, the Township should work together to educate the public and lake users on proper cleaning techniques and other invasive species information. A “Landing Blitz” can be held once the station is in place and the public can be invited to a field demonstration of how to use the washing station.** Figure 49 displays a typical CD3 boat washing station that is solar-powered.

Figure 49. A boat washing station on an inland lake.
