Pike Bay Aquatic Vegetation Evaluation with Professional Management Recommendations Houghton County, Michigan

Provided for: The Chassell Township Board

**Prepared by: Restorative Lake Sciences
Jennifer L. Jermalowicz-Jones, PhD, CLP
Water Resources Director
18406 West Spring Lake Road
Spring Lake, Michigan 49456
www.restorativelakesciences.com**

September, 2023

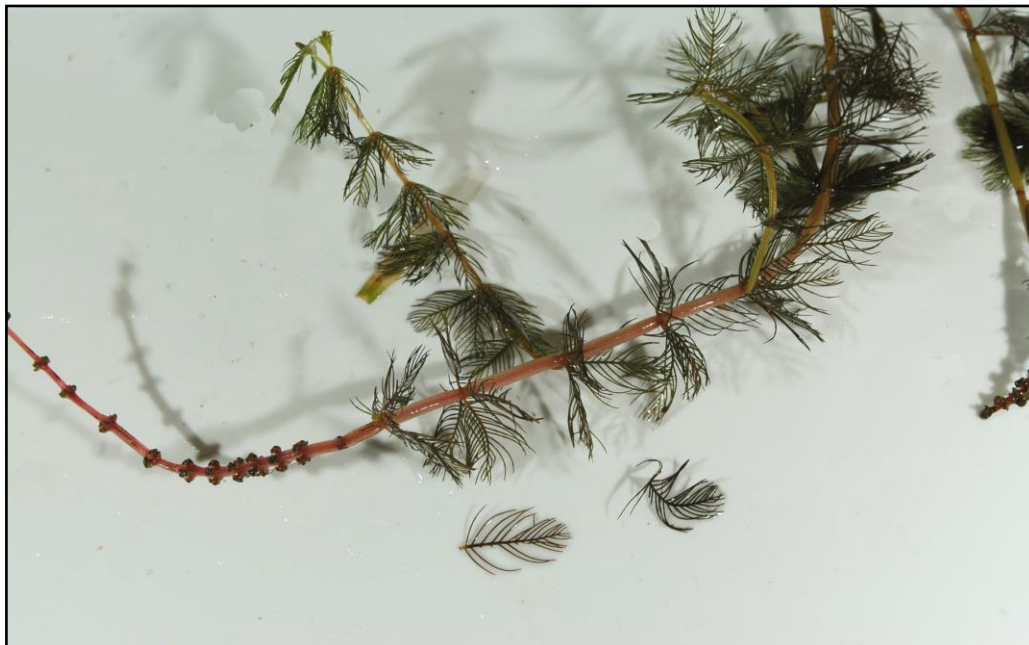
Figure 4. Hybrid Eurasian Watermilfoil plant with seed head and fragments (©RLS).

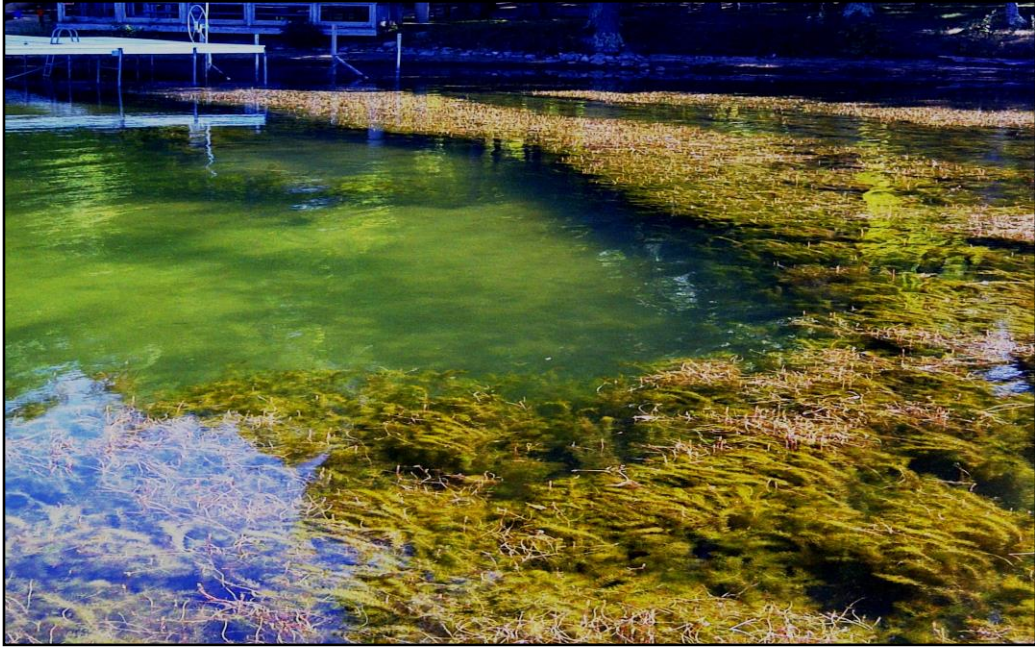
Figure 5. Hybrid Eurasian Watermilfoil Canopy on an inland lake (©RLS).

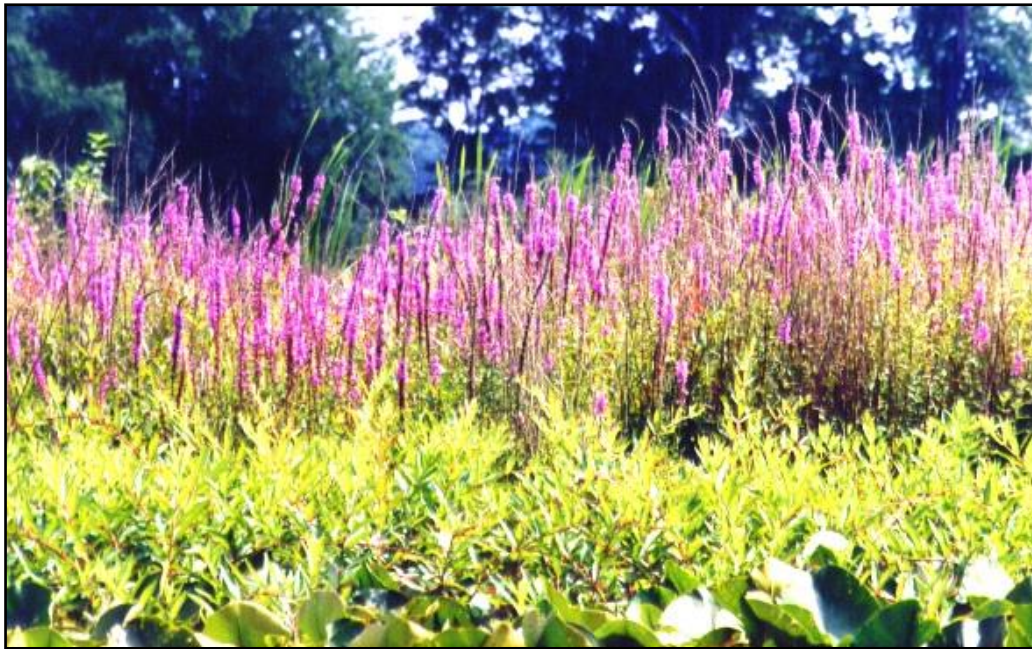
Figure 9. Invasive Purple Loosestrife invading a lake wetland.

Purple Loosestrife (*Lythrum salicaria*; Figure 9) is an invasive (i.e. exotic) emergent aquatic plant that inhabits wetlands and shoreline areas. *L. salicaria* has showy magenta-colored flowers that bloom in mid-July and terminate in late September. The seeds are highly resistant to tough environmental conditions and may reside in the ground for extended periods of time. It exhibits rigorous growth and may out-compete other favorable native emergents such as Cattails (*Typha latifolia*) and thus reduce the biological diversity of localized ecosystems. The plant is spreading rapidly across the United States and is converting diverse wetland habitats to monocultures with substantially lower biological diversity. It should be removed promptly if found (i.e., by hand pulling or using a shovel to remove the roots and then discarding the plant into the garbage) to avoid further infestation. If the plant is not promptly removed by hand, it could dominate in wetland areas and require larger-scale systemic herbicide treatments. **This plant was found in 25 locations around the shoreline of Pike Bay (Figure 10).**

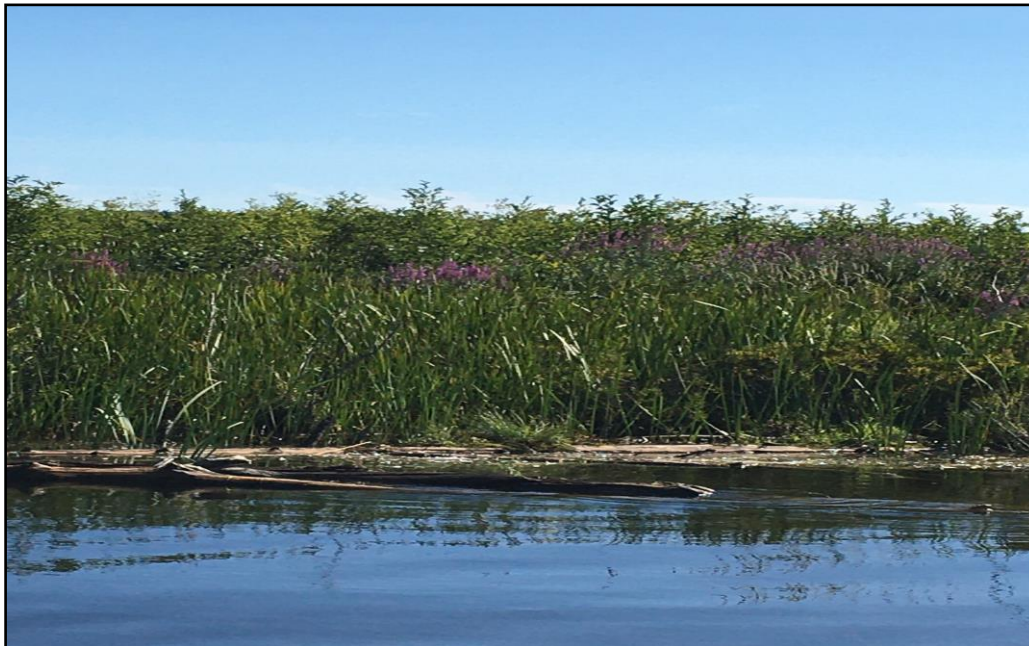
Figure 10. Invasive Purple Loosestrife around the shoreline of Pike Bay (August 27, 2023).

3. Purple Loosestrife can be hand-removed without the use of herbicides were it is found. The roots must be removed with a shovel and all of the plant discarded in a sealed bag.

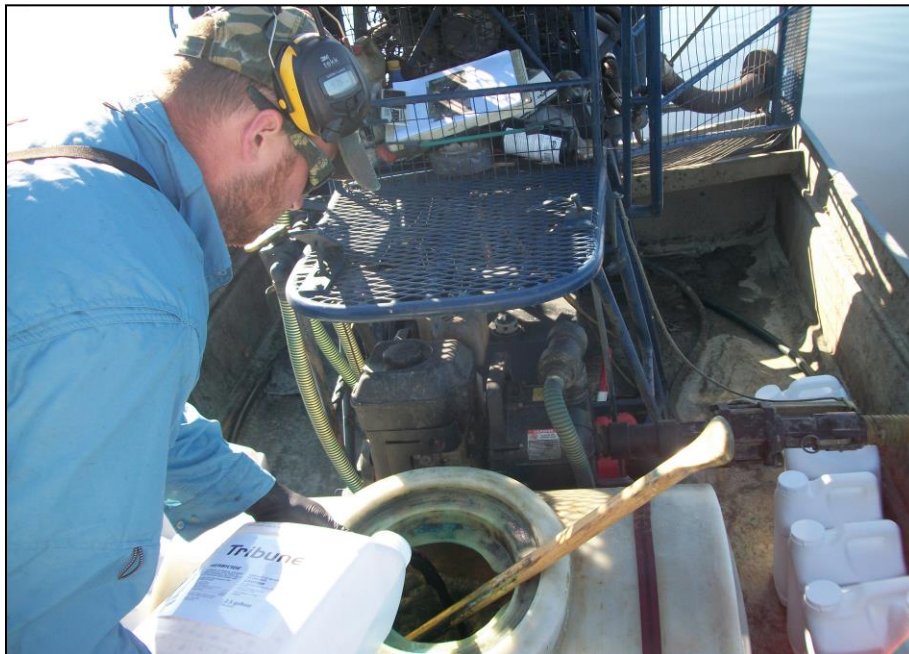
Figure 45. An herbicide treatment airboat and crew preparing for a lake treatment.

The use of aquatic chemical herbicides is regulated by the Michigan Department of Environment, Great Lakes, and Energy (EGLE) and requires a permit. Aquatic herbicides are generally applied via an airboat or skiff equipped with mixing tanks and drop hoses (Figure 45). The permit contains a list of approved herbicides for a particular body of water, as well as dosage rates, treatment areas, and water use restrictions. **Contact and systemic aquatic herbicides are the two primary categories used in aquatic systems.**

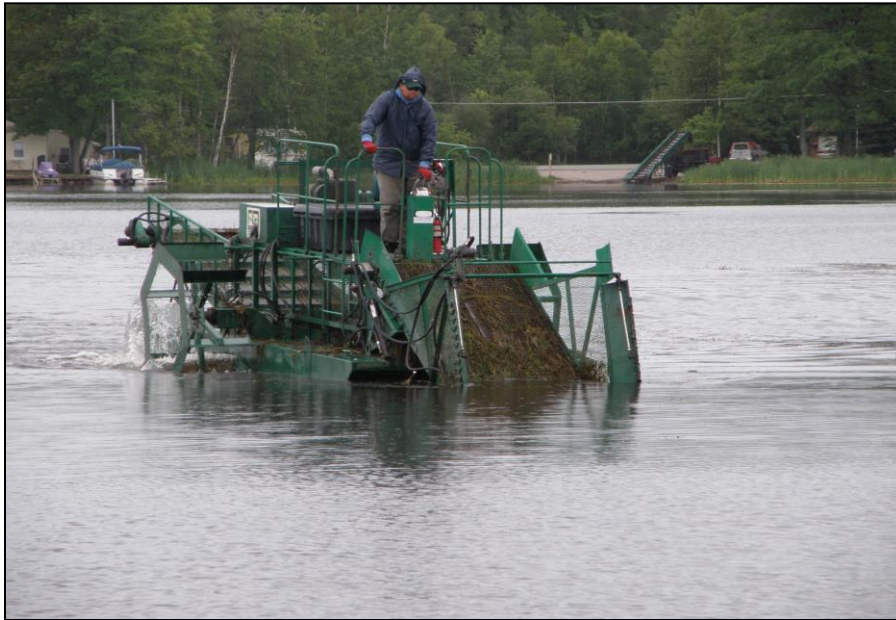
Figure 46. A mechanical harvester.

Mechanical harvesting involves the physical removal of nuisance aquatic vegetation with the use of a mechanical harvesting machine (Figure 46). The mechanical harvester collects numerous loads of aquatic plants as they are cut near the lake bottom. The plants are off-loaded onto a conveyor and then into a dump truck.

Harvested plants are then taken to an offsite landfill or farm where they can be used as fertilizer. Mechanical harvesting is preferred over chemical herbicides when primarily native aquatic plants exist, or when excessive amounts of plant biomass need to be removed. **Mechanical harvesting is usually not recommended for the removal of watermilfoil since the plant may fragment when cut and re-grow on the lake bottom.** In addition, it does not allow for removal of vegetation in target areas since Pike Bay has invasive milfoil growing with numerous native aquatic plant species.

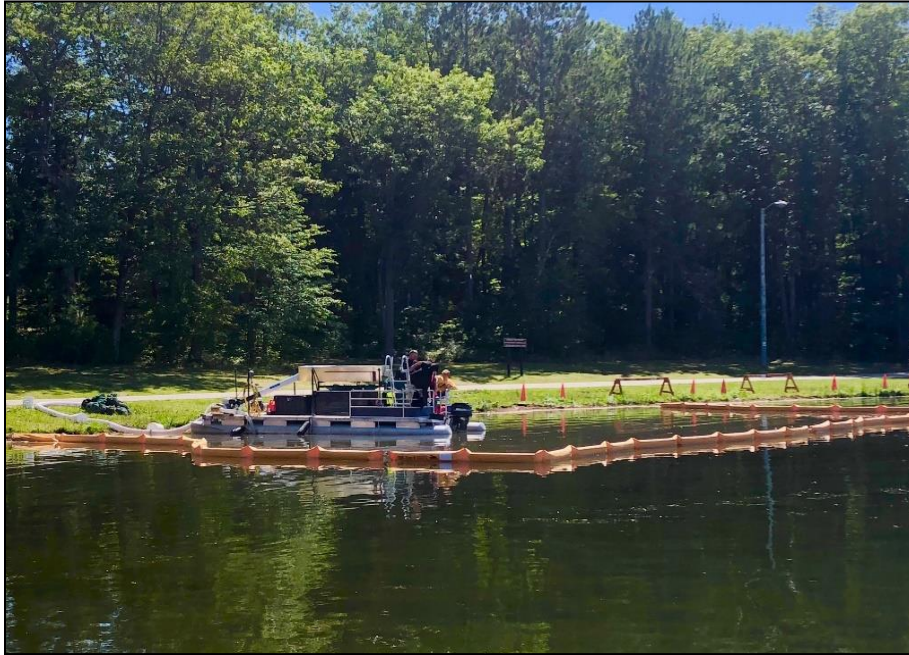
Figure 47. A DASH boat for hand-removal of watermilfoil or other nuisance vegetation. ©Restorative Lake Sciences

Suction harvesting via a Diver-Assisted Suction Harvesting (DASH) boat (Figure 47) involves hand removal of individual plants by a SCUBA diver in selected areas of lake bottom with the use of a hand-operated suction hose. Samples are dewatered on land or removed via fabric bags to an offsite location. **This method is generally recommended for small (less than 10 acres) spot removal of vegetation since it is usually cost-prohibitive on a larger scale.** The advantage it has is that it can be selective in what species it removes since a diver is guiding the suction hose to targeted plants.

This process may remove either plant material or sediments and may require a USACE bottomlands permit. Furthermore, this activity may cause re-suspension of sediments (Nayar et *al.*, 2007) which may lead to increased turbidity and reduced clarity of the water.

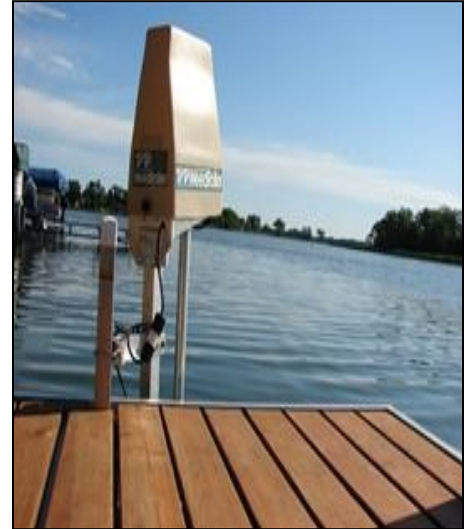
Figure 49. A Weed Roller.

The use of benthic barrier mats (Figure 48) or Weed Rollers (Figure 49) have been used to reduce weed growth in small areas such as in beach areas and around docks. The benthic mats are placed on the lake bottom in early spring prior to the germination of aquatic vegetation. They act to reduce germination of all aquatic plants and lead to a local area free of most aquatic vegetation. Benthic barriers may come in various sizes between 100-400 feet in length. They are anchored to the lake bottom to avoid becoming a navigation hazard.

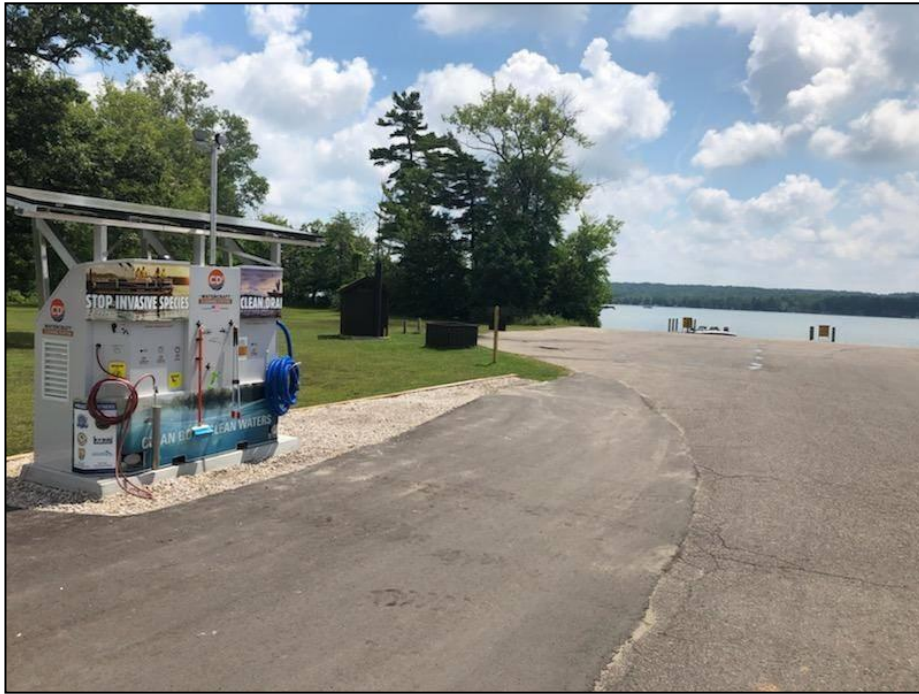
Figure 50. A boat washing station on an inland lake.

A “Landing Blitz” can be held once the station is in place and the public can be invited to a field demonstration of how to use the washing station. Figure 50 displays a typical CD3 boat washing station that is solar-powered.
