# Centennial Park Accessibility Report/ Onsite Review 6-8-19

Chassell Township requested a formal site review of their premier Centennial Park along the shoreline of Lake Superior. SAIL had earlier in the year supported the Township's efforts to have their updated five year Parks and Recreation Plan accepted by the Michigan Department of Natural Resources (DNR). At that time, SAIL recommended the Township consider a formal site review of Centennial Park for ADA compliance. Lynn Gierke, the Township Clerk managed arrangements for a formal site review in June after the Township voted to pay for a site review conducted by the Superior Alliance for Independent Living, a member of the Disability Network of Michigan(SAIL) to evaluate the site, and report the findings.

On June 8, 2019, SAIL evaluated Centennial Park. The evaluation was performed by Lucy Wilcox, a certified ADA Coordinator, and Allen and Joan Beauchamp, members of the Ambassador Accessibility Team. The team was joined by the Township Clerk, Lynn Gierke and a member of the Planning Committee of Chassell Township, Brian Waters.

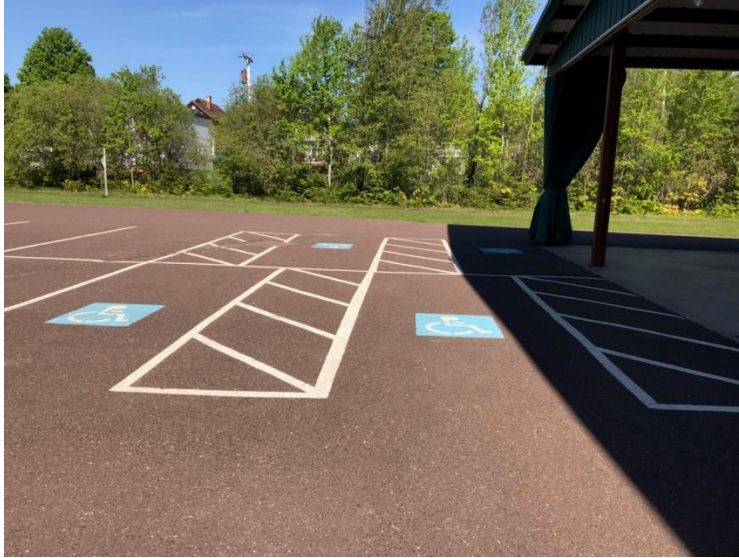
**A. The Parking Lot:** The parking lot surface is in good condition and there is more than adequate handicapped parking provided. Currently there is no standing signage to mark the Handicap accessible spaces as required by the ADA. The parking spaces are marked by paint markings on the pavement and there is no Van accessible parking designated. **Level 1 Recommendations: 1.** Purchase signage that can be posted at a minimum of 60 inches above the ground and designate 2 Van accessible parking spaces at the edge of the

2. The five accessible parking spaces of 8 ft wide positioned next to the Pavilion as you reach the west side of the parking lot actually exceed the required number by ADA guidelines and Chassell is commended for their planning. **Level 1 modification-** There is the need to meet ADA signage standards for the five spaces with each space marked with handicap signage at least 60 inches above the parking lot. Painted signage is optional and during winters in the UP not effective. We recommend the new signage that shows the wheelchair in motion, the Go Logo. It is essential to preserve the access lanes of at least 5 feet wide shared by 2 autos.

parking lot close to Lake Superior. Given the space available designating the two spaces 8 feet each and sharing an access aisle of 8 feet would utilize spaces already in place. **Level 1 Recommendations:** 1. Purchase signage that can be posted at a minimum of 60 inches above the ground and designate 2 Van accessible parking spaces at the edge of the parking lot close to Lake Superior. Given the spaces are already designated handicapped parking--the main change is the designation as Van Accessible and these spaces do provide the easiest access route into the Pavilion.

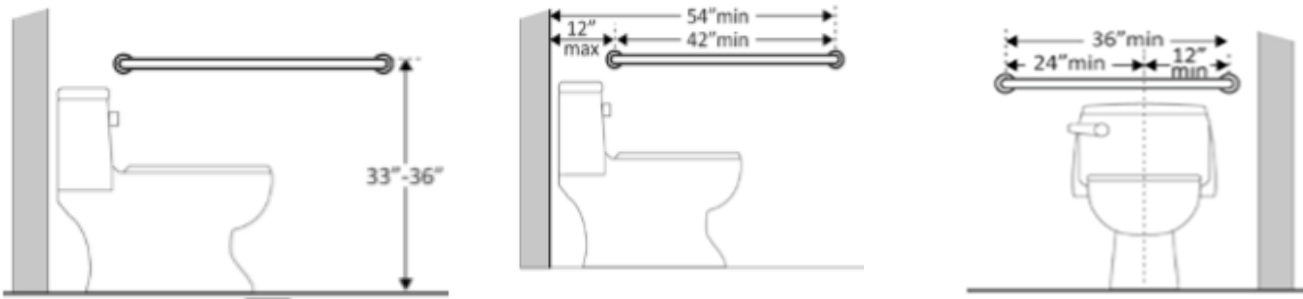
**V. Toilet rooms near the fish cleaning station-** The review team directed their consideration of accessible toilets to the separate toilet rooms near the fish cleaning station. The Chassell participants believed the two restrooms there are accessible. We will review accessible routes to the building in the next section. The two restrooms are identical and both are accessible with one readily resolved barrier. To be accessible there must be a turning radius once inside the toilet room of 60 inches. That standard is met. There must be hand bars placed with specific requirements of the length of the hand bars and the alignment with the toilet. The diagrams above show the required measurements for the hand bars in an accessible bathroom. The standards were met for the hand bars behind the toilet and on the wall beside the toilet.

However, adding the vertical bar (which is definitely not an ADA standard) created an error in the location of the toilet paper holder so it is inaccessible to the user and the space between the bar and toilet holder is not sufficient. There were holes in the cement block that indicated the holder had been moved when the vertical bar was added. **The Level 1 recommendation** is to revert to the original set up without the vertical bar.

As both restrooms are identical, it is a **Level 1 recommendation** the signage be changed from Men and Women to unisex or all gender and both toilets could be used by any person. This could make the toilets available for whomever comes next regardless of sex/gender. Also signage needs to meet the standards to be accessible for low vision or blind users. The reviewers can provide information about purchasing signage that meets ADA standards for all signage standards and the placement of the signage on the doors or to the side opposite of the door opening.
